# Spectrum24 CB1000 for IBM 4690 Terminals

## User Guide

72E-66778-01  
Revision A  
December 2003

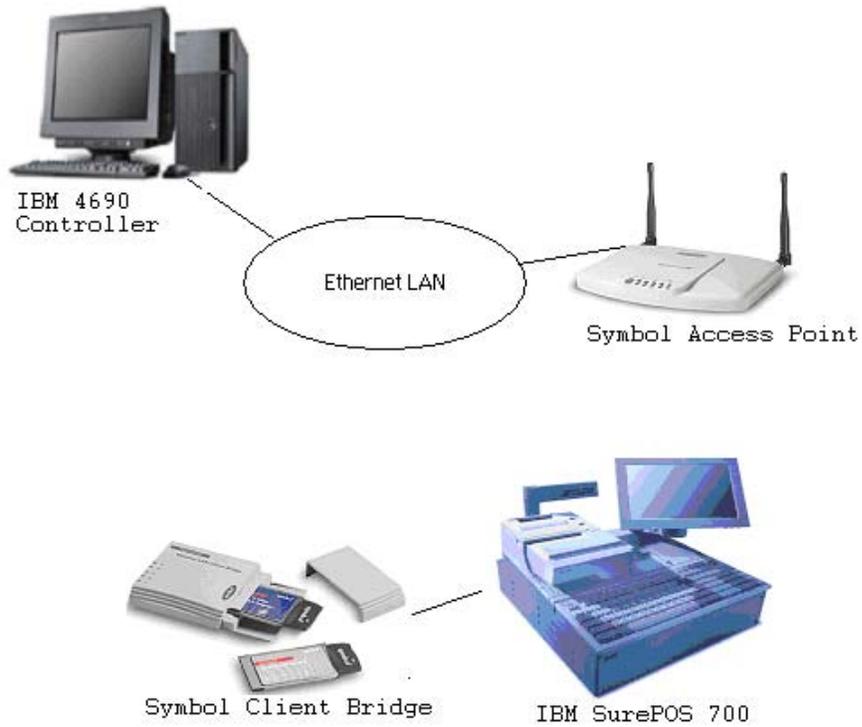
The IBM SurePOS 700 can connect to the Symbol CB1000 through an Ethernet cable. The CB1000 contains a Symbol Spectrum24 PCMCIA radio card with an antenna. The CB1000 transmits messages wirelessly to the Symbol Access Point, which forwards the messages to the IBM 4690 Controller over the Ethernet LAN.
